CONFIDENTIAL HOME INSPECTION REPORT

Sample Dr, Sample City, MN

client: Sample
inspection date: 7-15-2024

report #9060

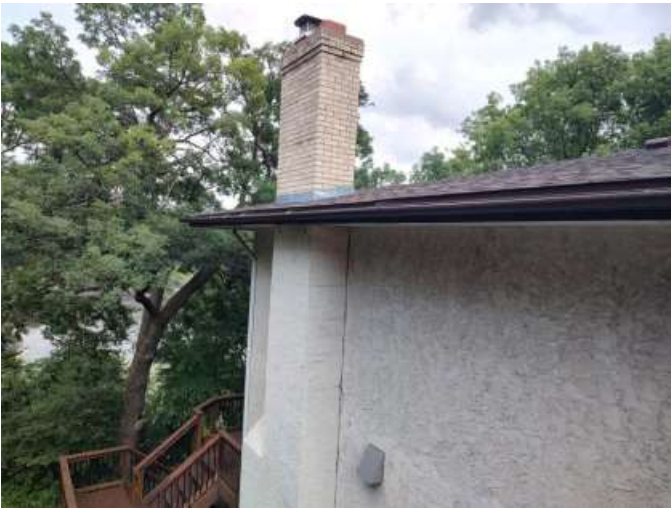
Portions of the gutters are sagging, which will prevent water from draining properly (water may overflow the gutters at these locations). This is often caused by ice buildup / ice dams.

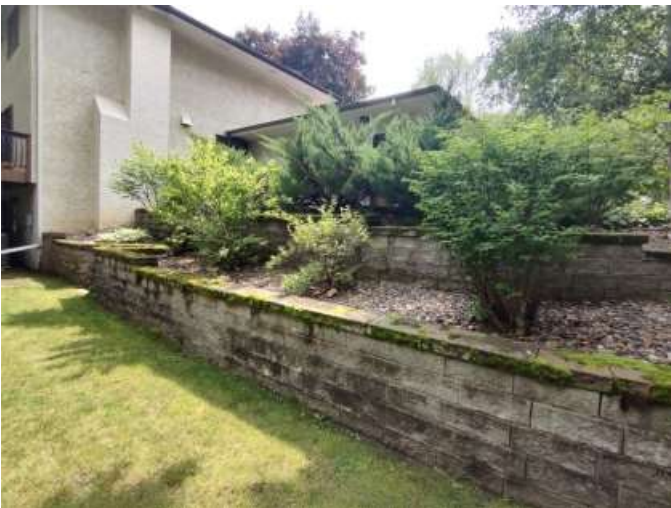
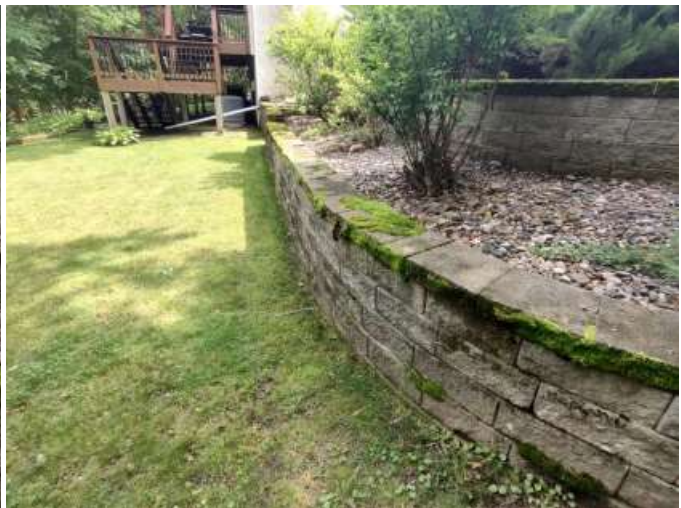
Portions of the retaining wall are leaning (at back side of home), which is usually caused by excessive water accumulation on the back side. In most cases, this indicates that the back sides of the walls were not properly designed (i.e. lack of drain tile and / or gravel). There also are not drainage holes installed.

The cap stones are not secured in place. This creates a potentially hazardous condition - for any children / people that may walk on the top of the walls.

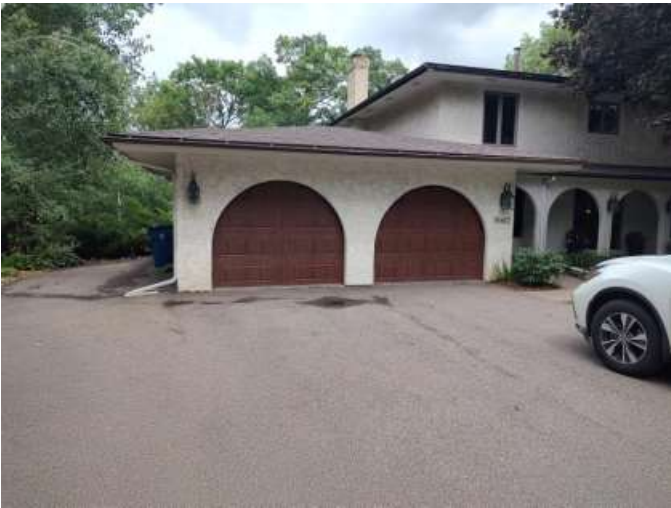
The driveway is partially directing water toward the garage, which means that periodic leakage into the garage could occur during heavy rainfalls.

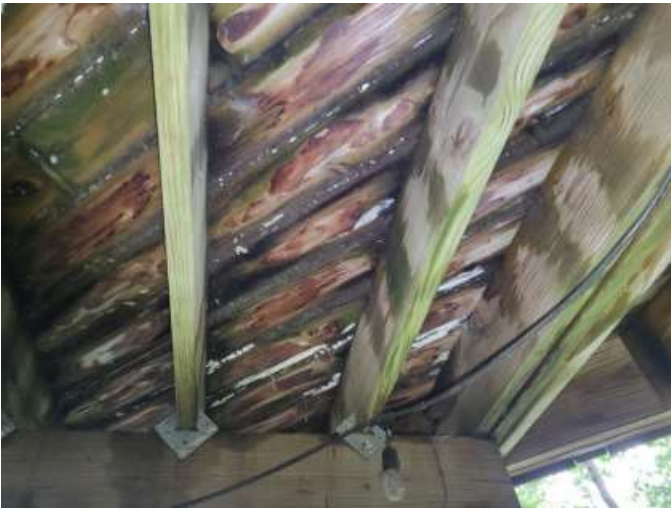
Portions of the floorboards have decayed.

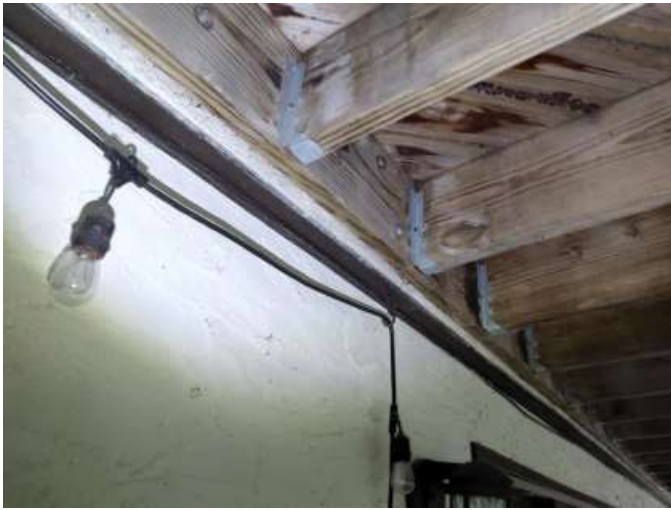
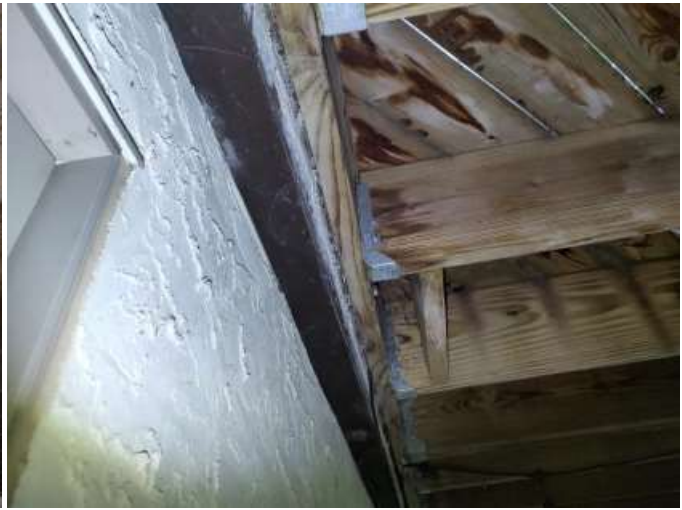
The deck was anchored directly to the stucco siding. While this is commonly found, it is considered improper to anchor a deck directly to stucco siding. The preferred installation is to have a beam (with posts / footings) installed near the home - transforming the deck into a free-standing structure.

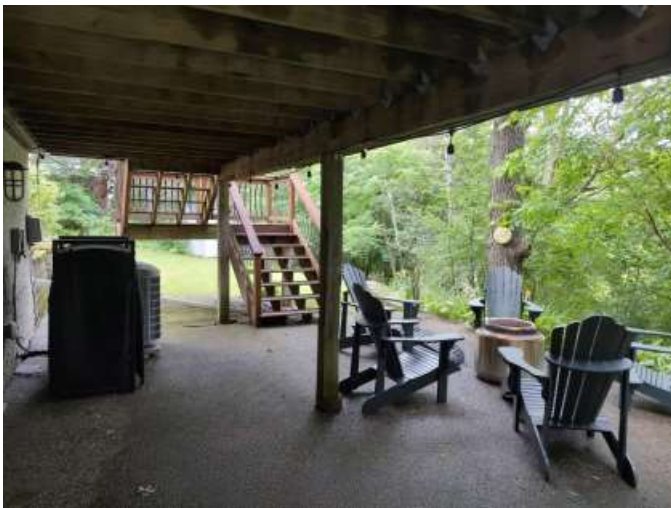
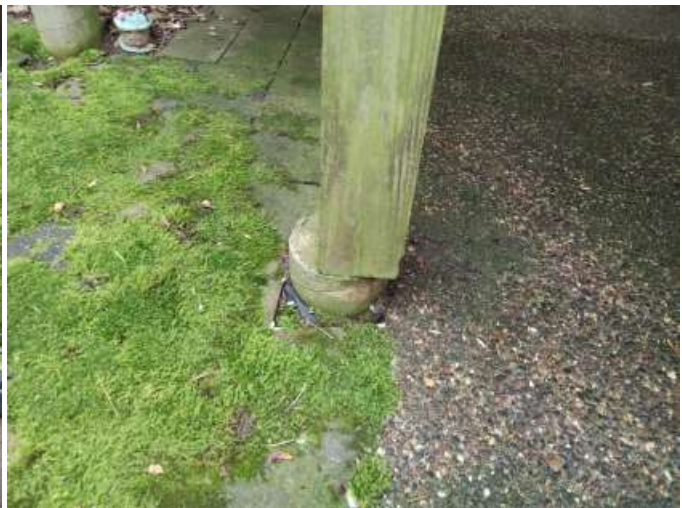
The posts are not pinned to the footings with manufactured connections (connectors / isolation stools are now required).

Some posts also were not centered on their footings - and the bottom portion of one post has cracked.

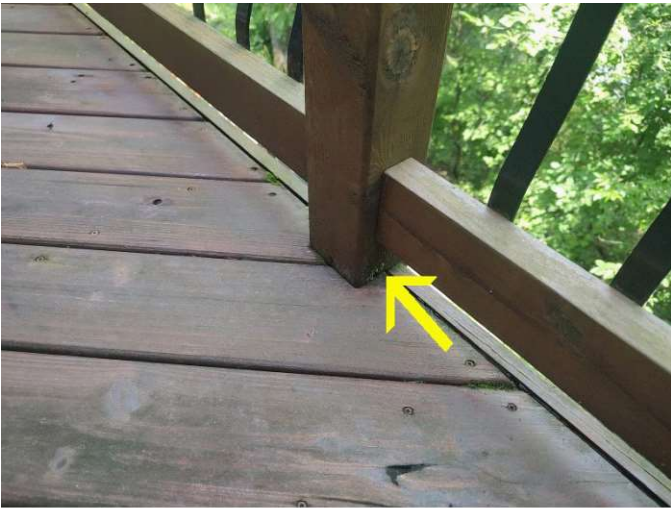
Decay is occurring at the base of some deck rail posts (where the posts were notched).

decay at notched locations

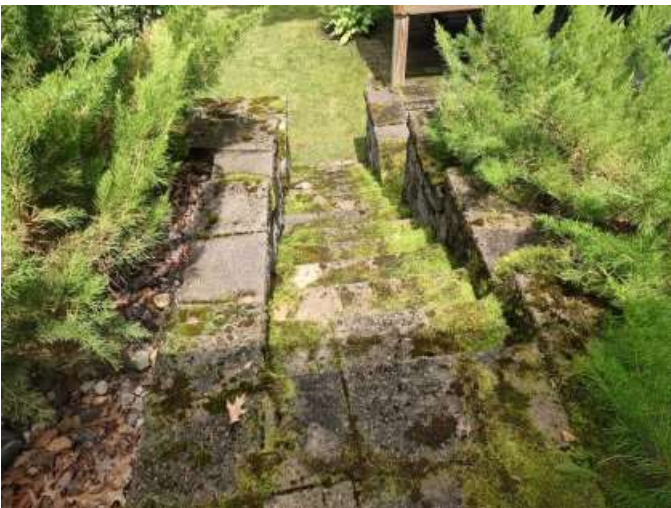
There is no handrail installed on the exterior staircase (back side of garage). The steps are also covered with moss, which creates a serious potential falling hazard.

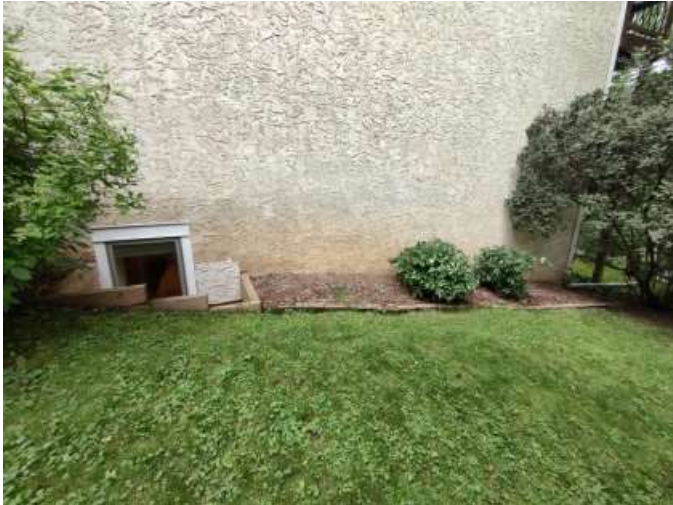
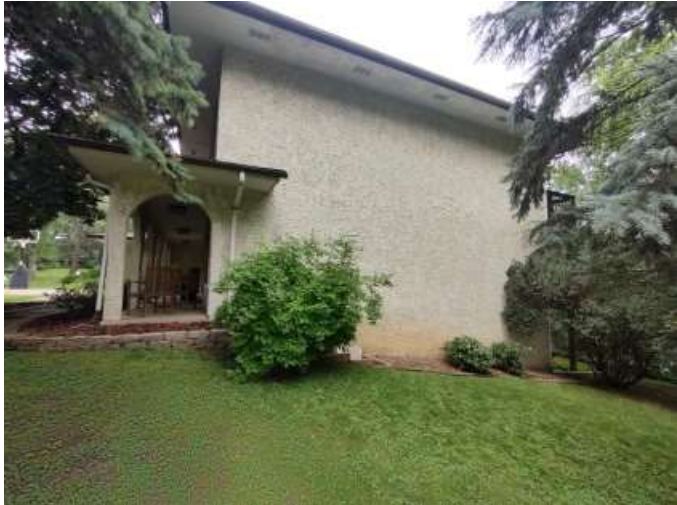
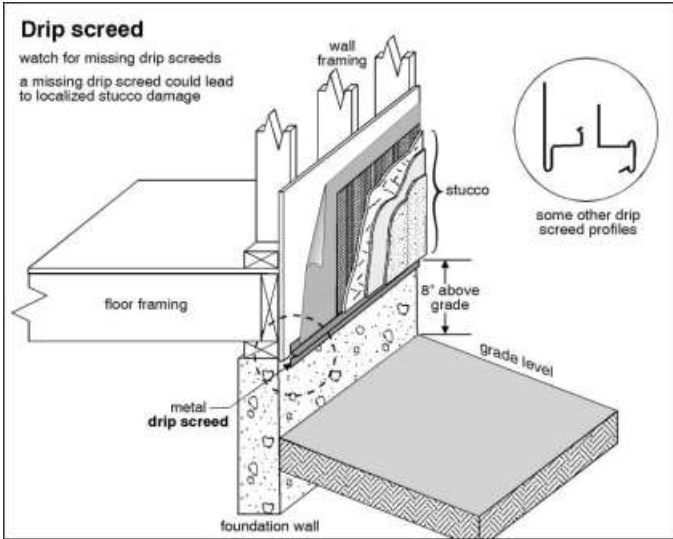
The stucco has inadequate clearance to the soil at most locations - and is contacting the soil at many of these locations. While this is common for the year the house was built, it is improper. Modern codes require stucco to terminate 4" above the soil and 2" above paved surfaces.

When stucco is in contact with the soil, it can allow moisture to wick into the wall structure - and can also prevent moisture from completely draining out from behind the stucco - resulting in deterioration at the base of the walls over time.

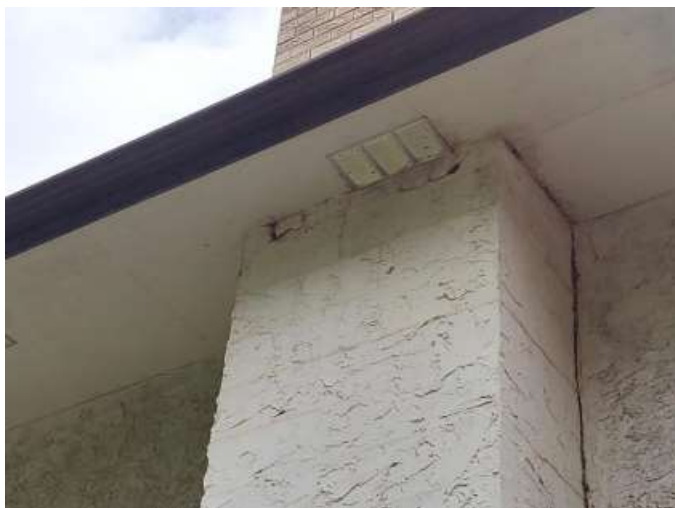
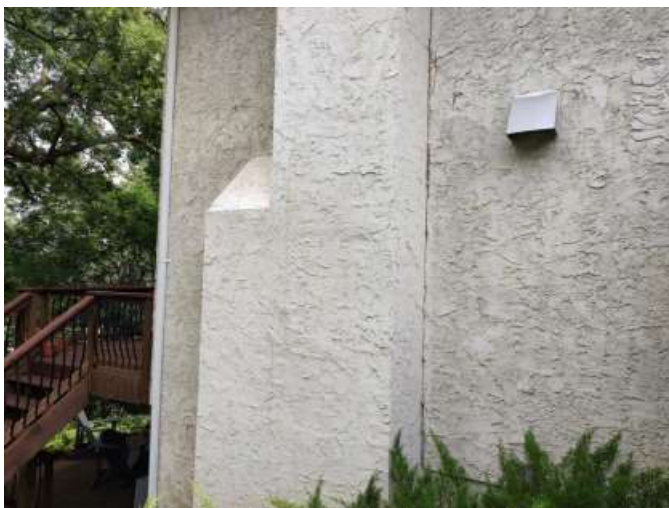
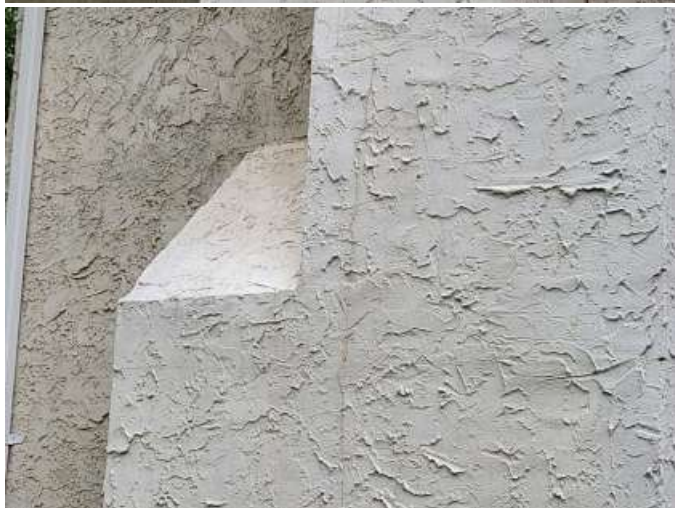
Portions of the chimney chase stucco have deteriorated / cracked.

Note: In some cases, masonry that is coated with stucco will deteriorate over time. The condition of the brick was not determined during the inspection.

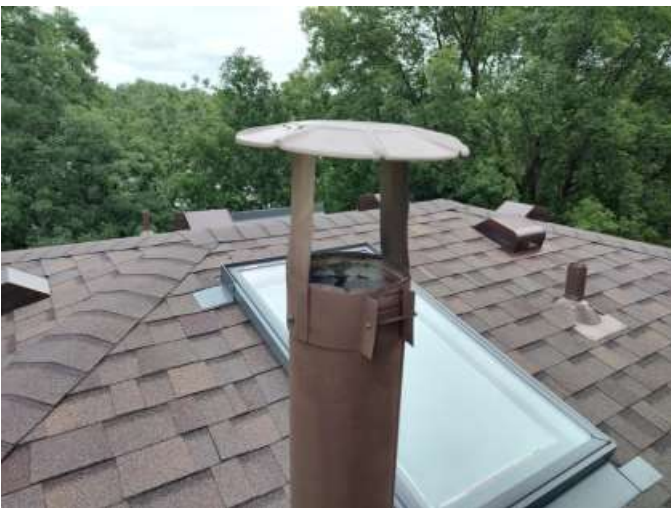
The abandoned flue does not have a proper cover / cage at the vent opening. Note: This flue is no longer used for any of the appliances. A noise was occurring inside the flue at the time of the inspection, which could indicate that a bird is stuck inside.

A proper cap will help to prevent birds / debris from falling into the vent. This vent opening can be permanently sealed.

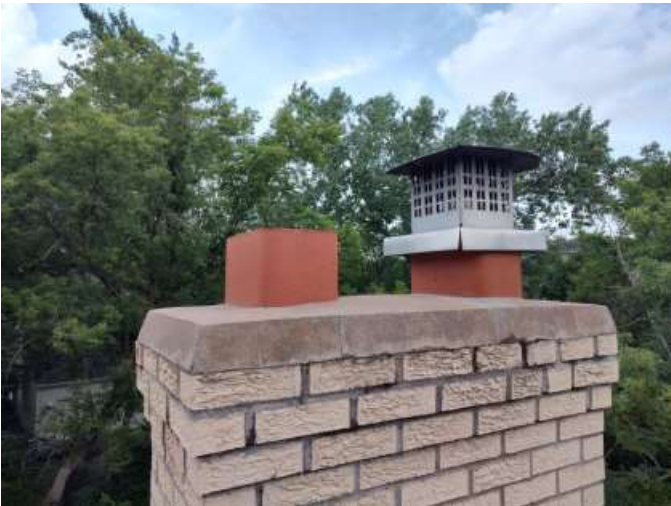
There is no cover on the wood burning chimney opening. Covers help prevent sparks from exiting the chimney and they also prevent animals, leaves and rain from entering the chimney. Chimney covers should also include a mesh that surrounds the opening.

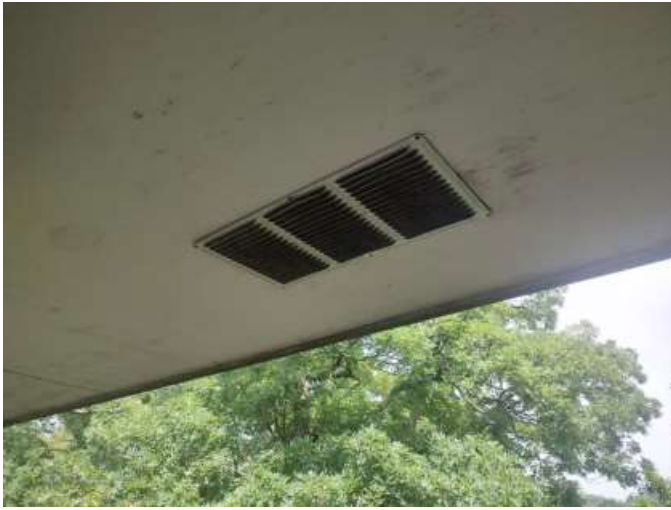
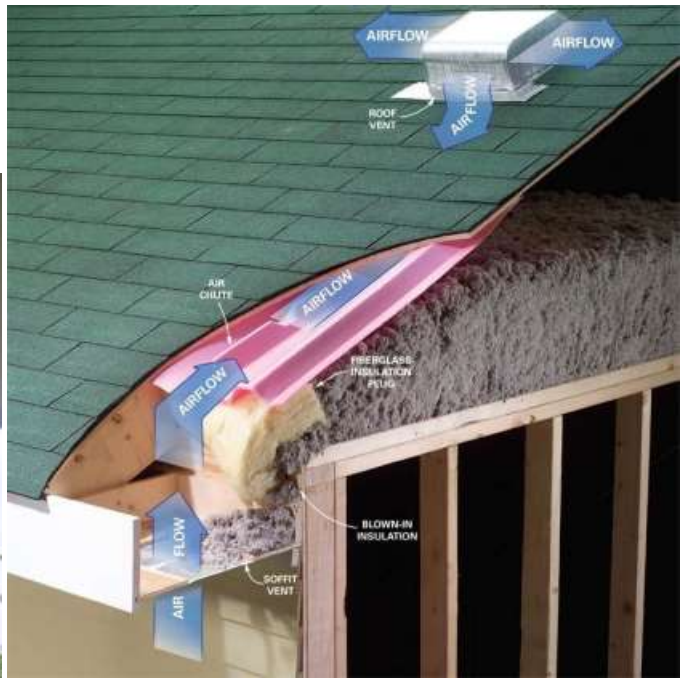
Several soffit vents are clogged with debris. Cleaning these is recommended to allow for proper ventilation into the attic area.

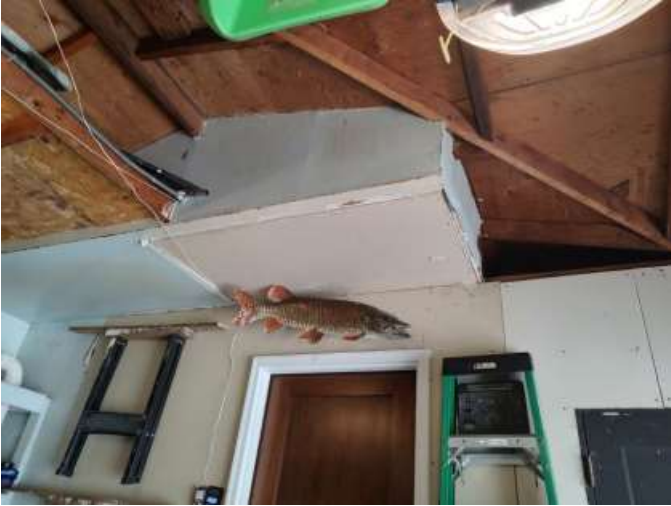
There is no tape / mud at the wall / ceiling drywall joints.

According to the fire code, all walls that connect to living portions of the home must be completely covered with a fire-rated material (i.e. drywall) and most cities also require the joints to be sealed with tape & mud.

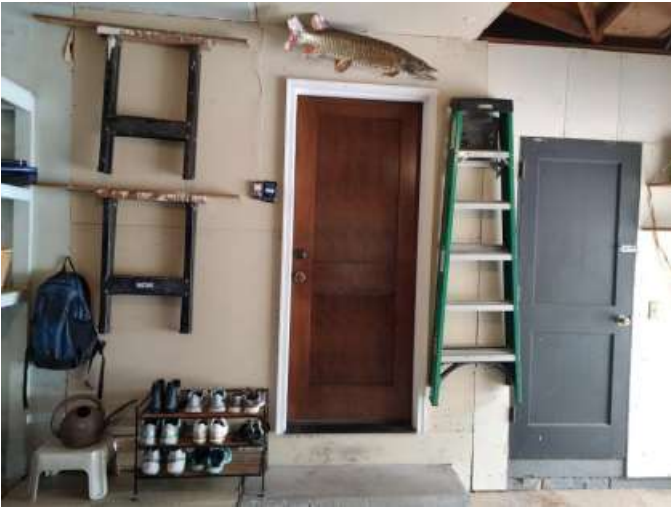
The door is not made from a fire rated material (metal door or 1 3/8" solid core wood door).

The door to the house is not self-closing. A self-closing mechanism is recommended for interior service doors (this prevents car exhaust from entering the home).

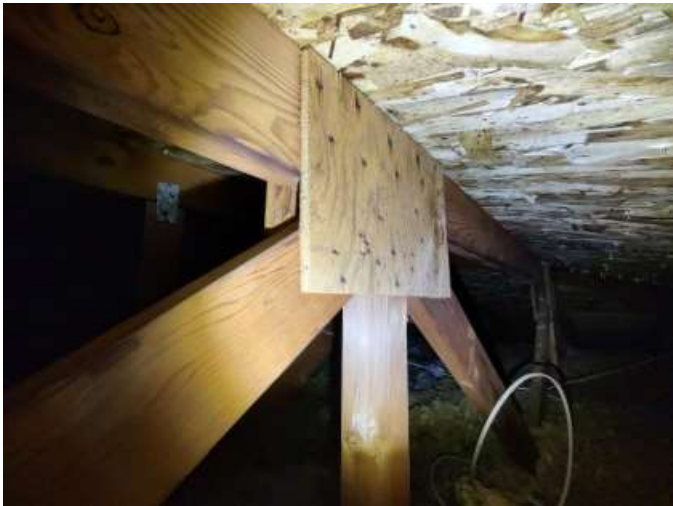
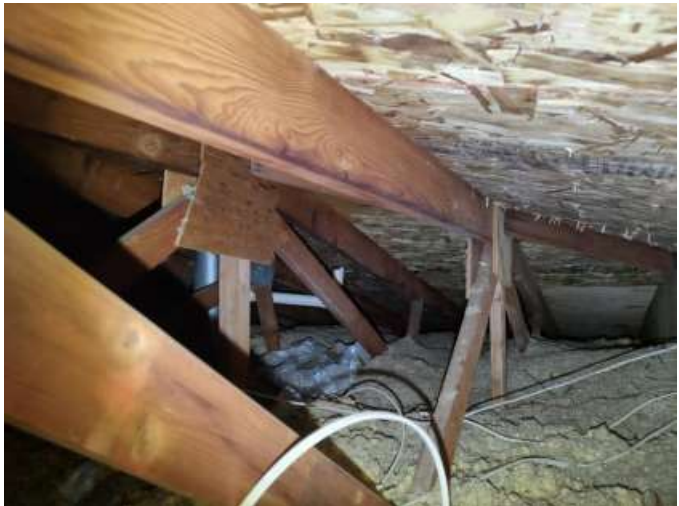
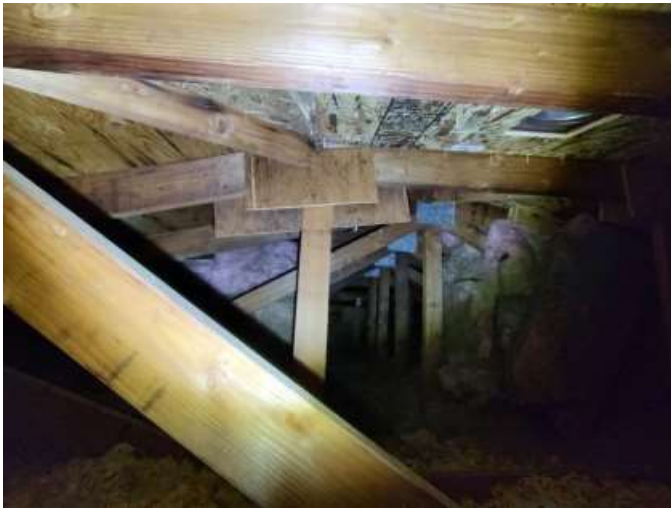
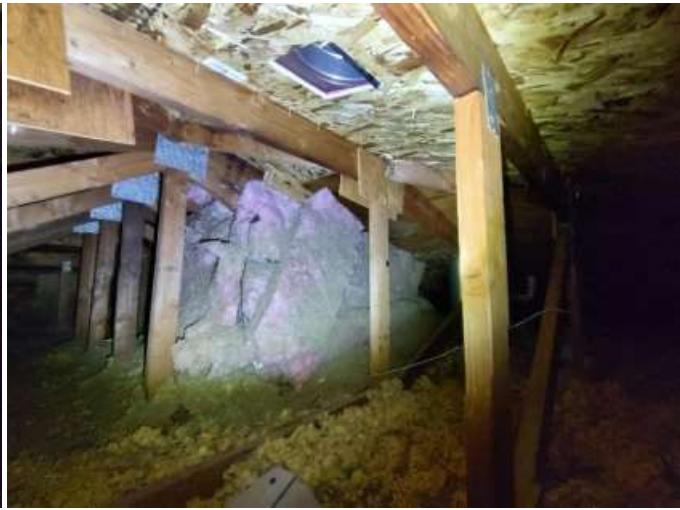
Repairs were made at several truss plate locations (plywood has been used to replace the metal truss plates). These repairs appear to have been made by a professional, but we suggest that you ask the seller for any paperwork associated with the repairs - for re-sale purposes (repairs to trusses should only be made by licensed professionals - and must be approved by a structural engineer).

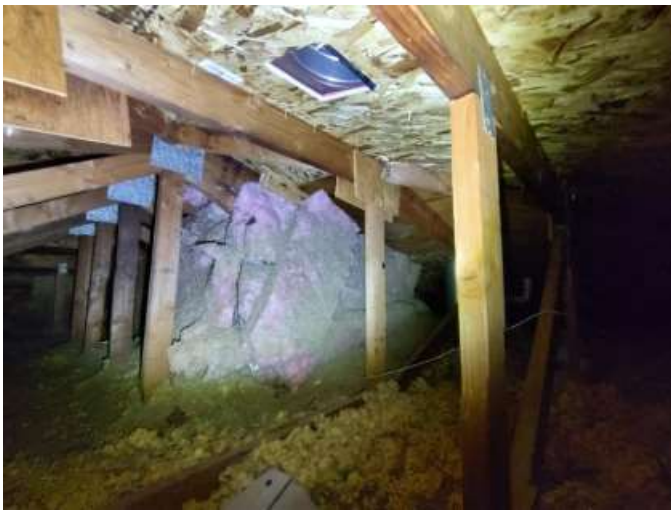
Fiberglass insulation was used to insulate the skylight. This material is a poor insulator because gaps will exist, which allow large amounts of house air / heat to leak into the attic space. This often results in condensation on the attic structure and ice buildup on the roof during winter months. Note: Spray foam insulation is the best way to insulate a skylight chase.

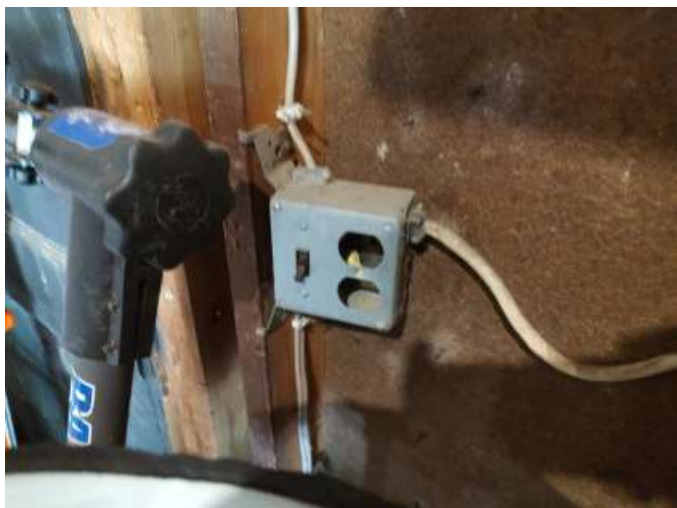
An improper junction box was used at one location (wire connections are exposed).

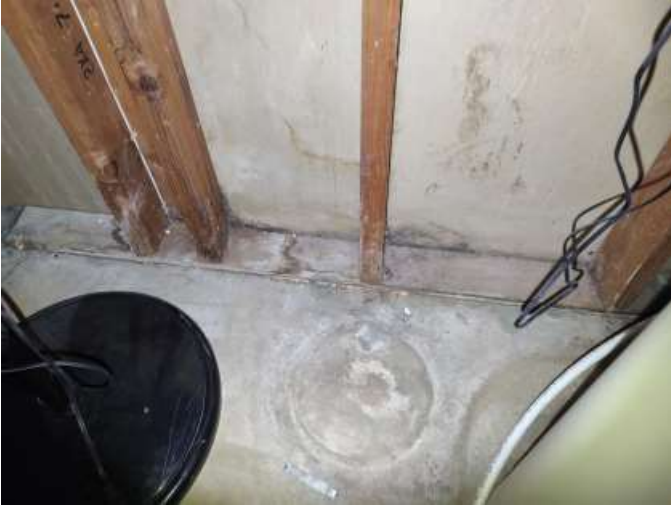
Mildew stains exist at the bottom portions of some furnace room walls (indicating that water has pooled on the floor at one time).

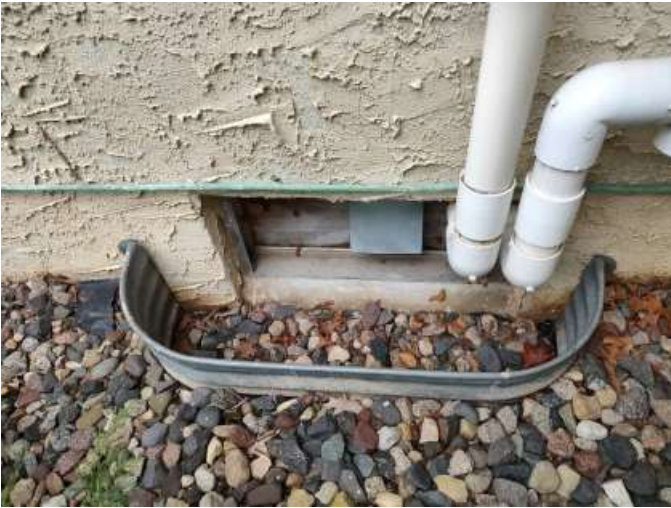
The air intake opening is located inside a window well - and could be buried with snow during winter months. Modifications to the vent opening are recommended so that it telescopes higher above the soil.

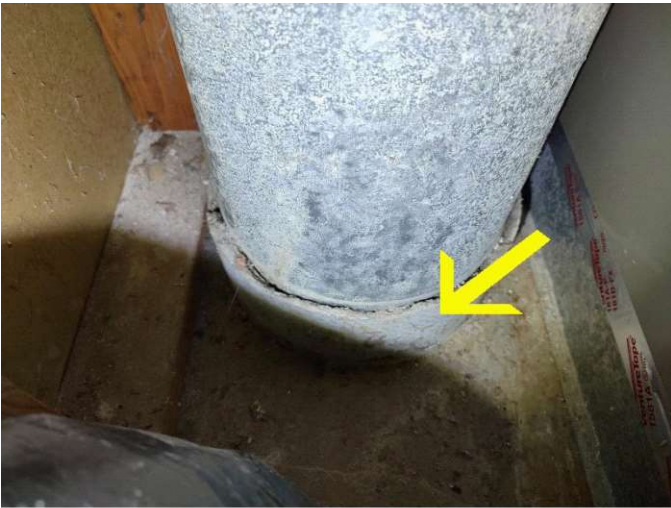
The cut edges of this material are often rough / friable - and have the potential to release microscopic asbestos particles into the air if disturbed. This means that the ductwork probably should not be cleaned.

metal transitions to transite @ floor slab

If desired, you can have ceiling / wall registers installed in the basement - and can have the existing in-floor ducts permanently sealed. A specialist can provide repair options and estimates, if desired.

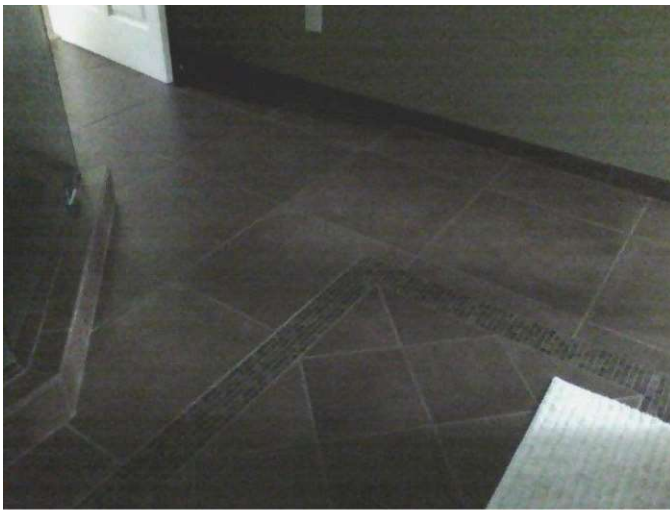
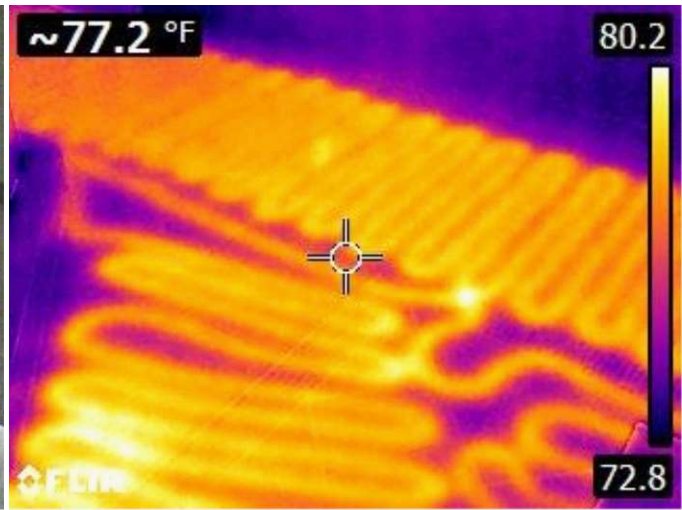
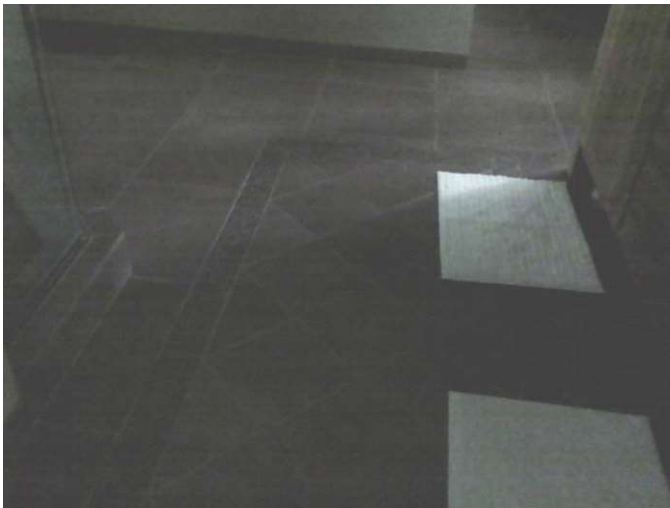
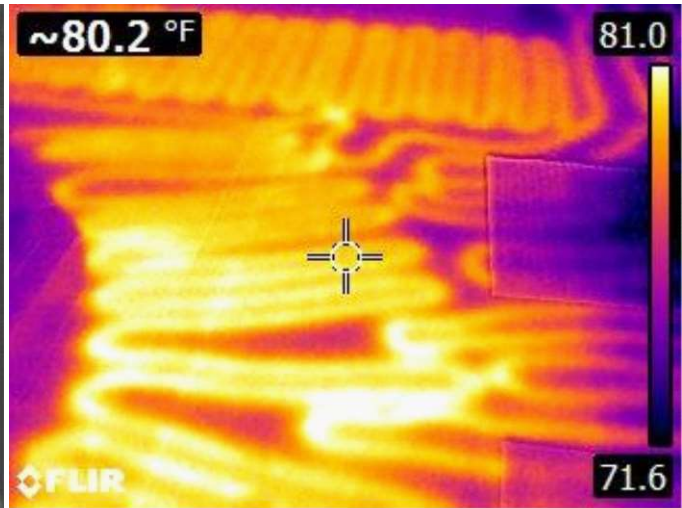
The heating coils were viewed with infrared. Note: An irregular pattern was used for the coils in the master bathroom.

irregular pattern

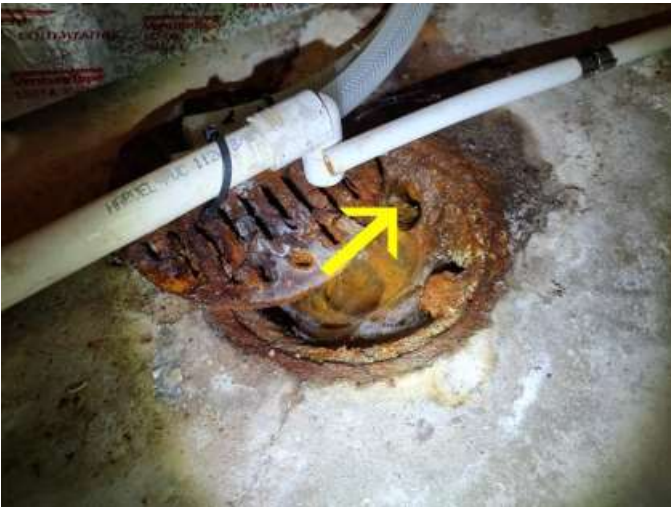
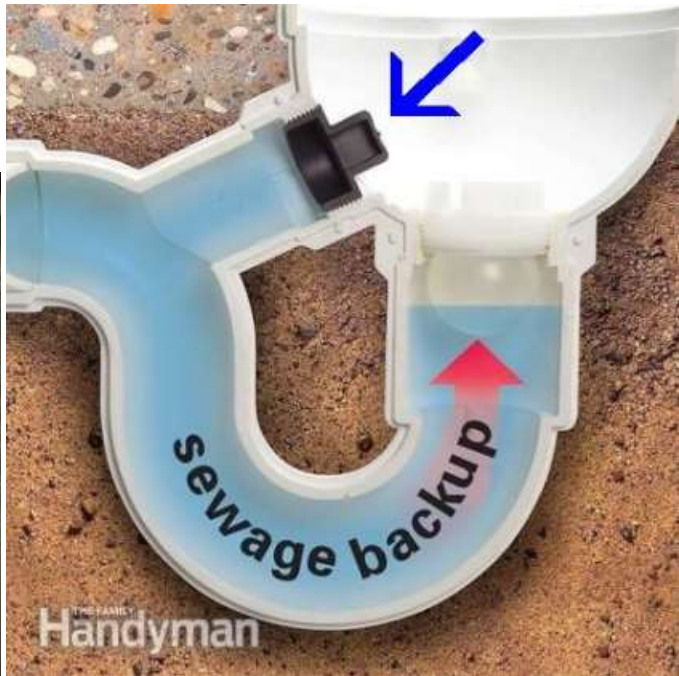
The access plug is not in place, which allows sewer gases to enter the home. In this case, the drain threads are stripped, which means that a rubber plug with a steel core and wing nut fitting will likely be needed.

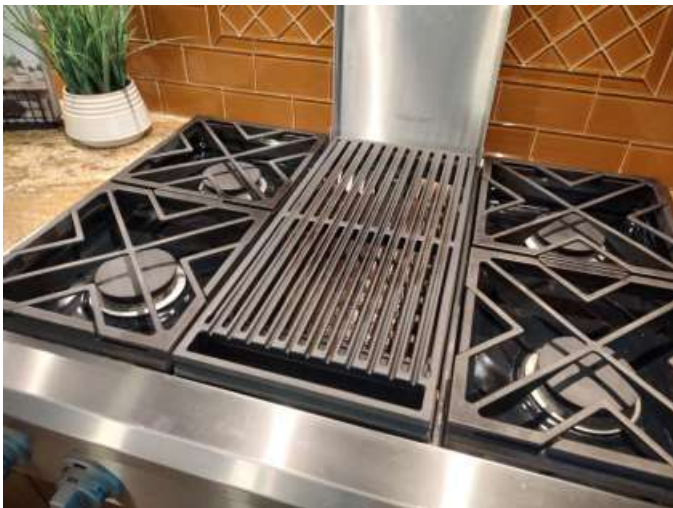
Portions of the center / grill burners are smoking when in use.

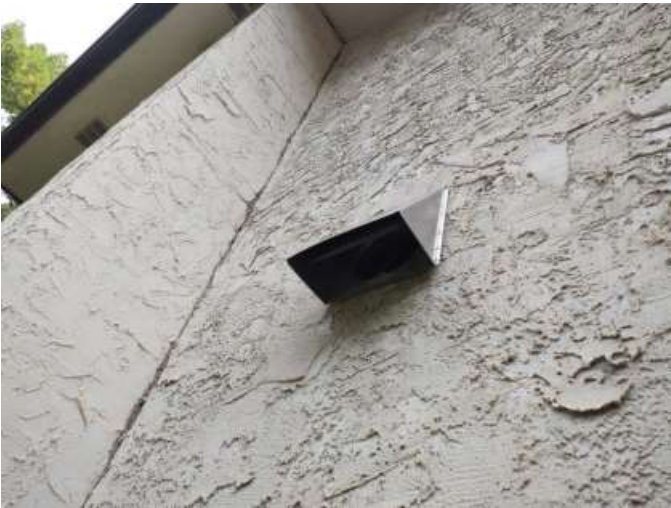
There is no pest screen installed over the kitchen vent opening (at house exterior).

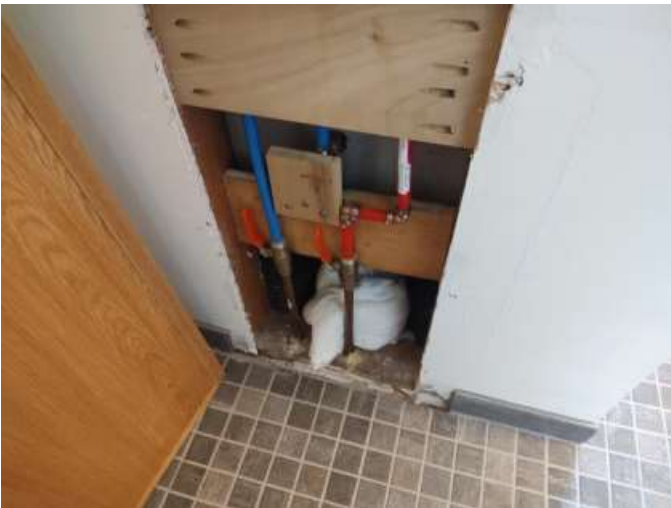
A towel has been wrapped around portions of the bathtub plumbing (below the upstairs hallway bathtub). This may indicate that leakage has occurred at one time. No signs of active leakage were found at the time of the inspection, but this area should be periodically monitored. Note: The overflow drain was not tested for leakage.

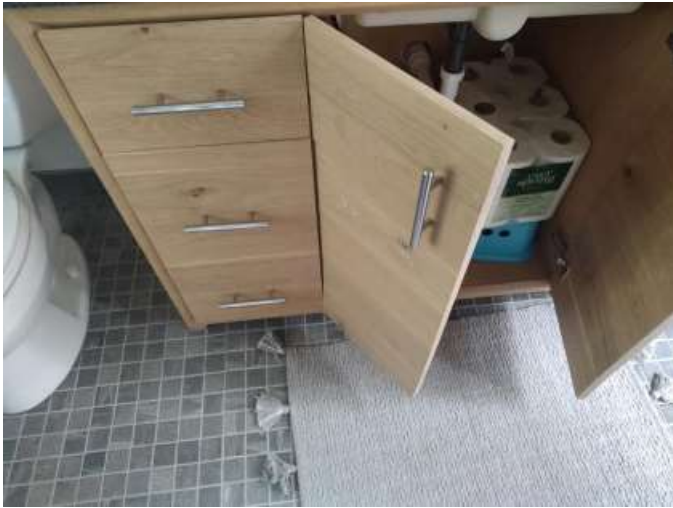
The cabinet doors are warped - at the vanity in the upstairs hallway bathroom.

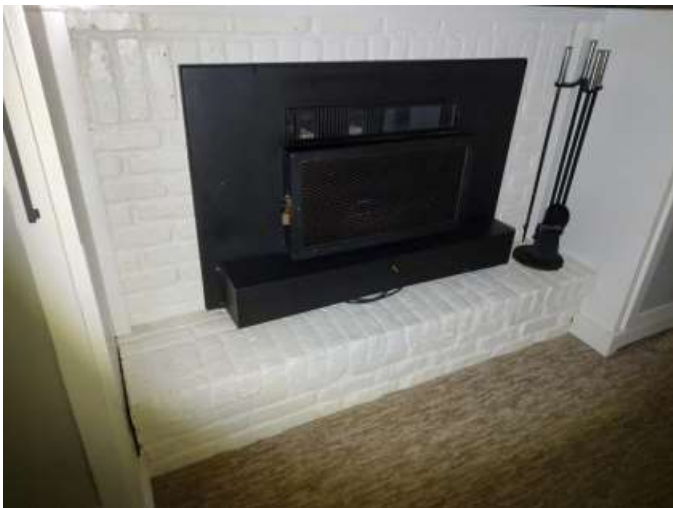
The hearth extension extends less than 16" in front of the fireplace opening.
