CONFIDENTIAL HOME INSPECTION REPORT

Sample Dr, Sample City, MN

client: Sample
inspection date: 7-15-2024

report #9060

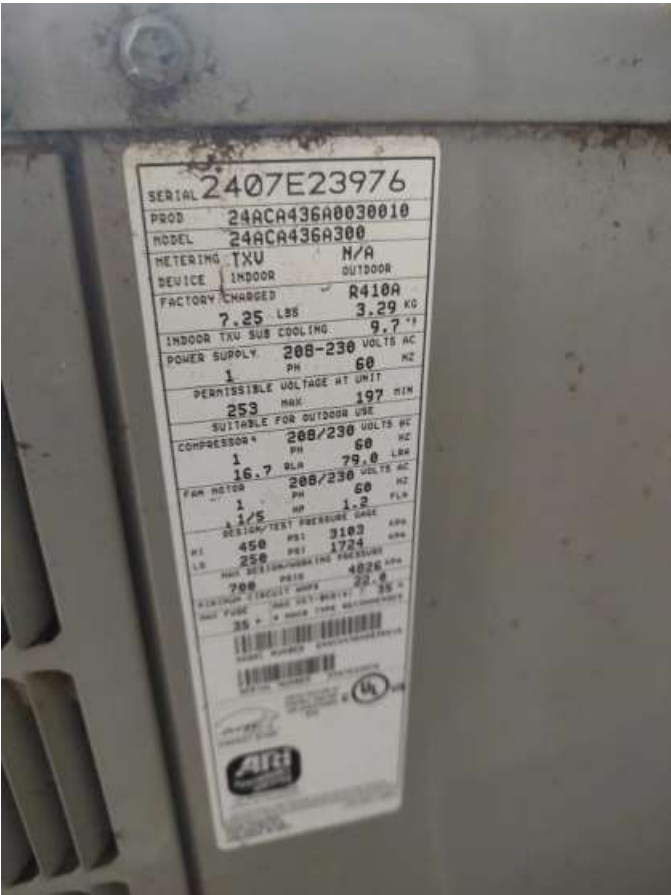
MANUFACTURE DATE:
2024.

REFRIGERANT TYPE:
R-410A.

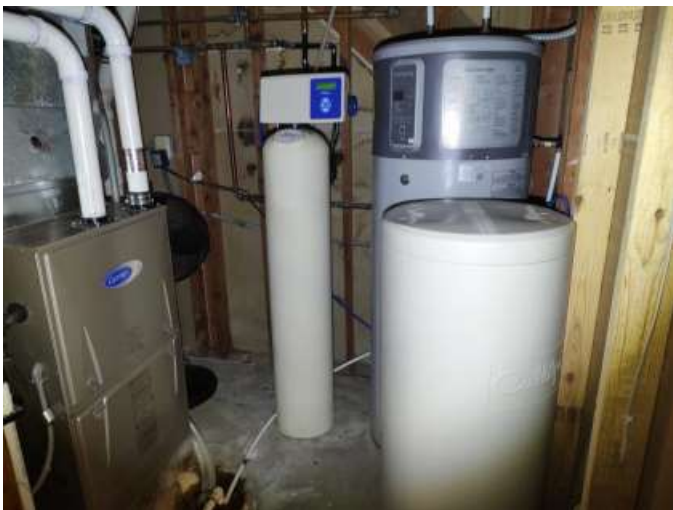
Note: Water softeners are not tested for operation - the condition and effectiveness of the unit was not determined. The average lifespan of a softener is approximately 15 years. Effectiveness decreases (sometimes significantly) after this. This unit appears to have been recently installed. I suggest that you ask the sellers for more information.

When water becomes visible at the base of the tank, it is time to refill the tank (2 bags per fill is recommended).

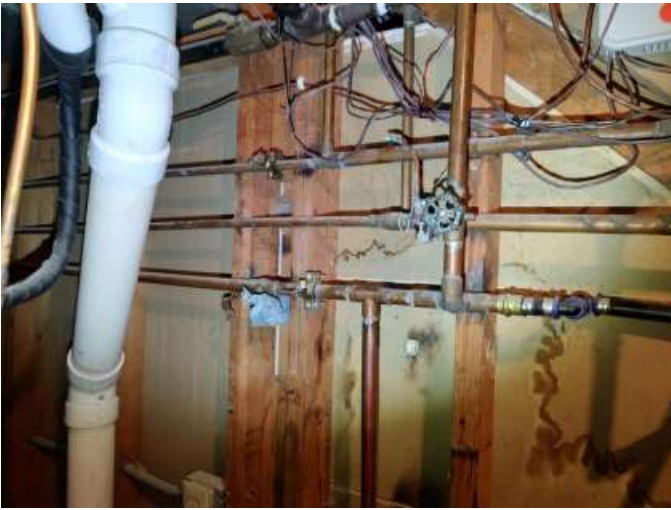
Note: The shut off valves for the spigots are old and are susceptible to leakage. Upgrading to modern ball valves is recommended.

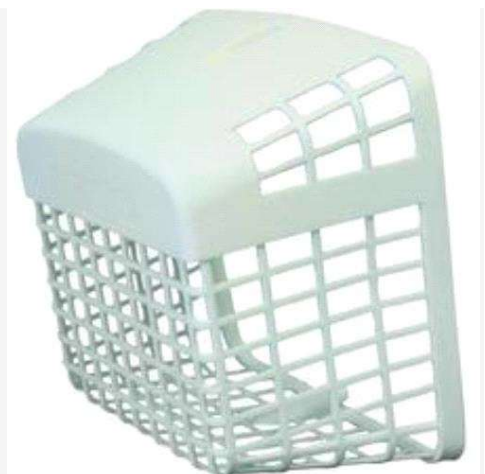
sample pest screen

There is no pest screen installed over the basement bathroom vent opening (located at house exterior).

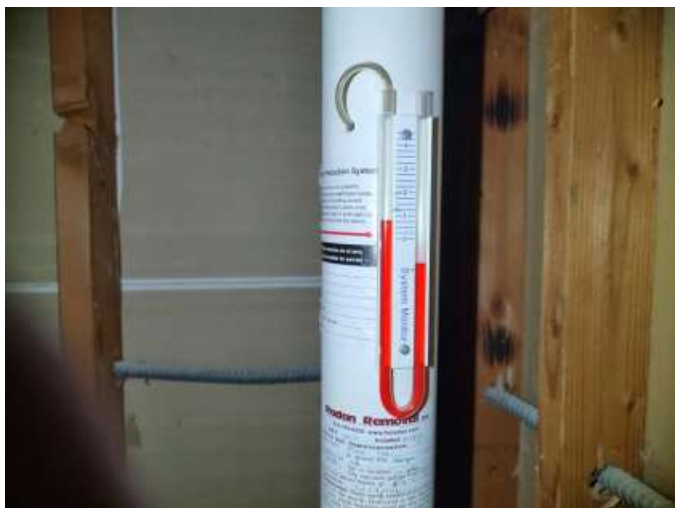
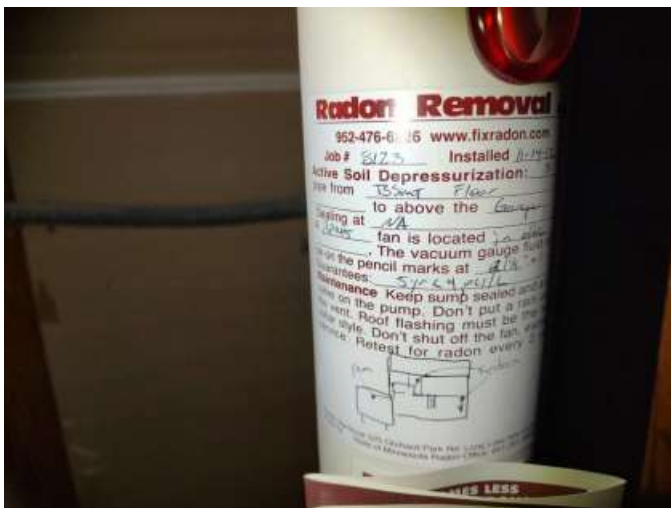
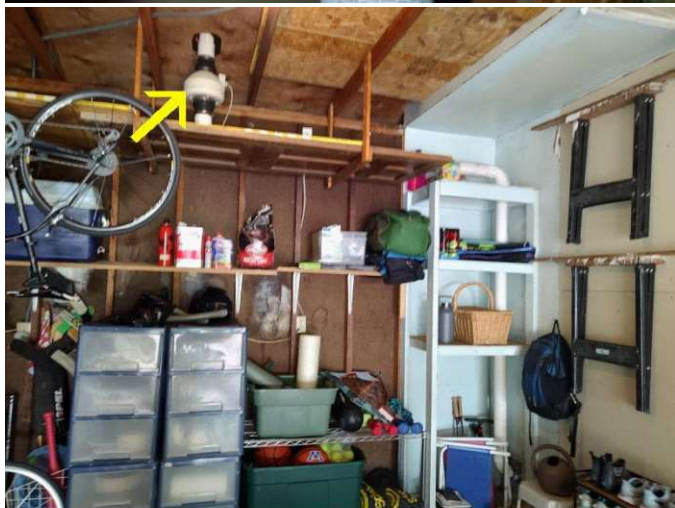
fan located in garage

An active radon mitigation system has been installed. The system has two suction points; both start in the basement, but only one was accessible. They combine into one pipe and extend through the garage roof. There is the possibility that this radon mitigation system has an extended warranty that is transferable.
